MEMORANDUM REPORT

SANITARY SEWERAGE SYSTEM REPAIRS

ROCKY MOUNTAIN ARSENAL-COMMERCE CITY, COLORADO

OCTOBER 1979

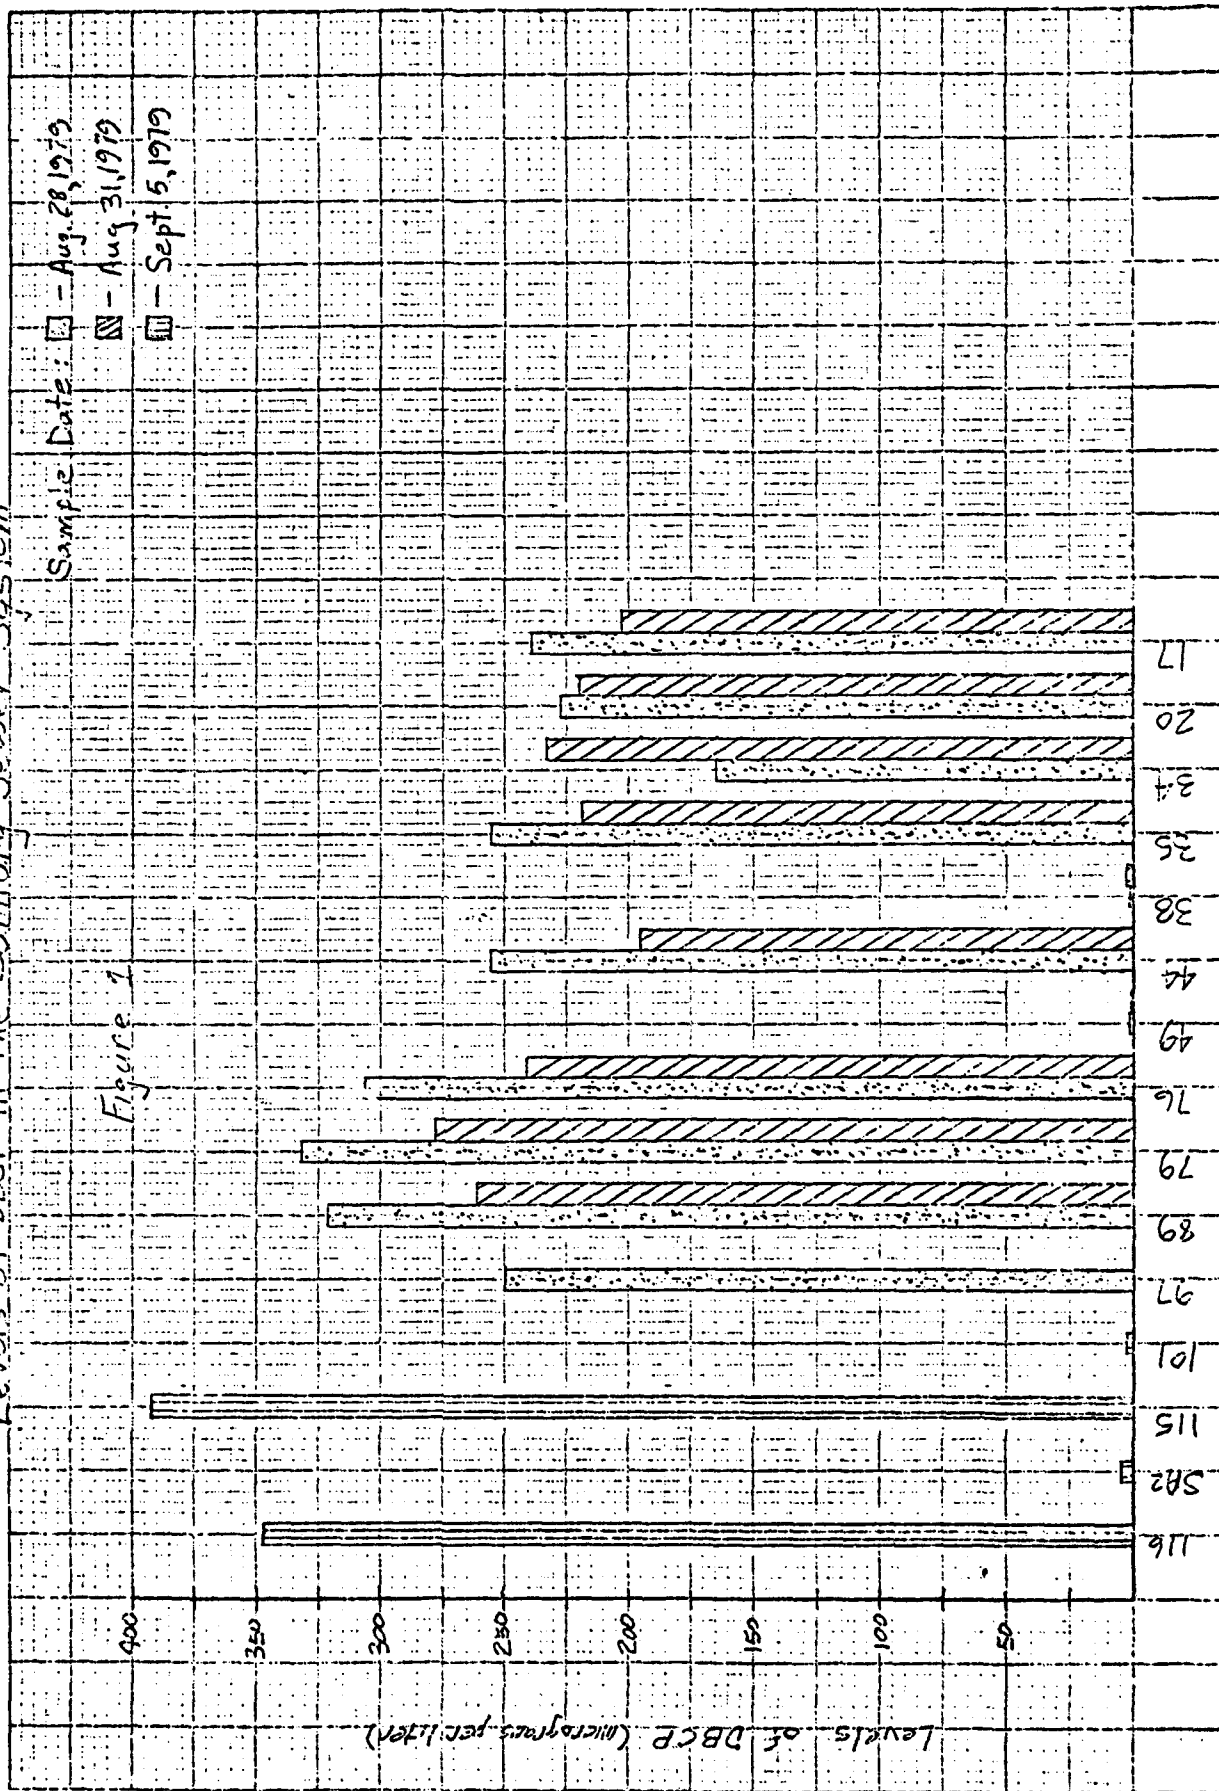
Figure 1

13. Chemical samples indicate contaminant leakage into the sanitary sewer system is occurring, particularly in the South Plant Area.
14. Dilution of the contaminants observed in South Plant sewage flows is occurring downstream in the system as evidenced by the chemical sampling program.

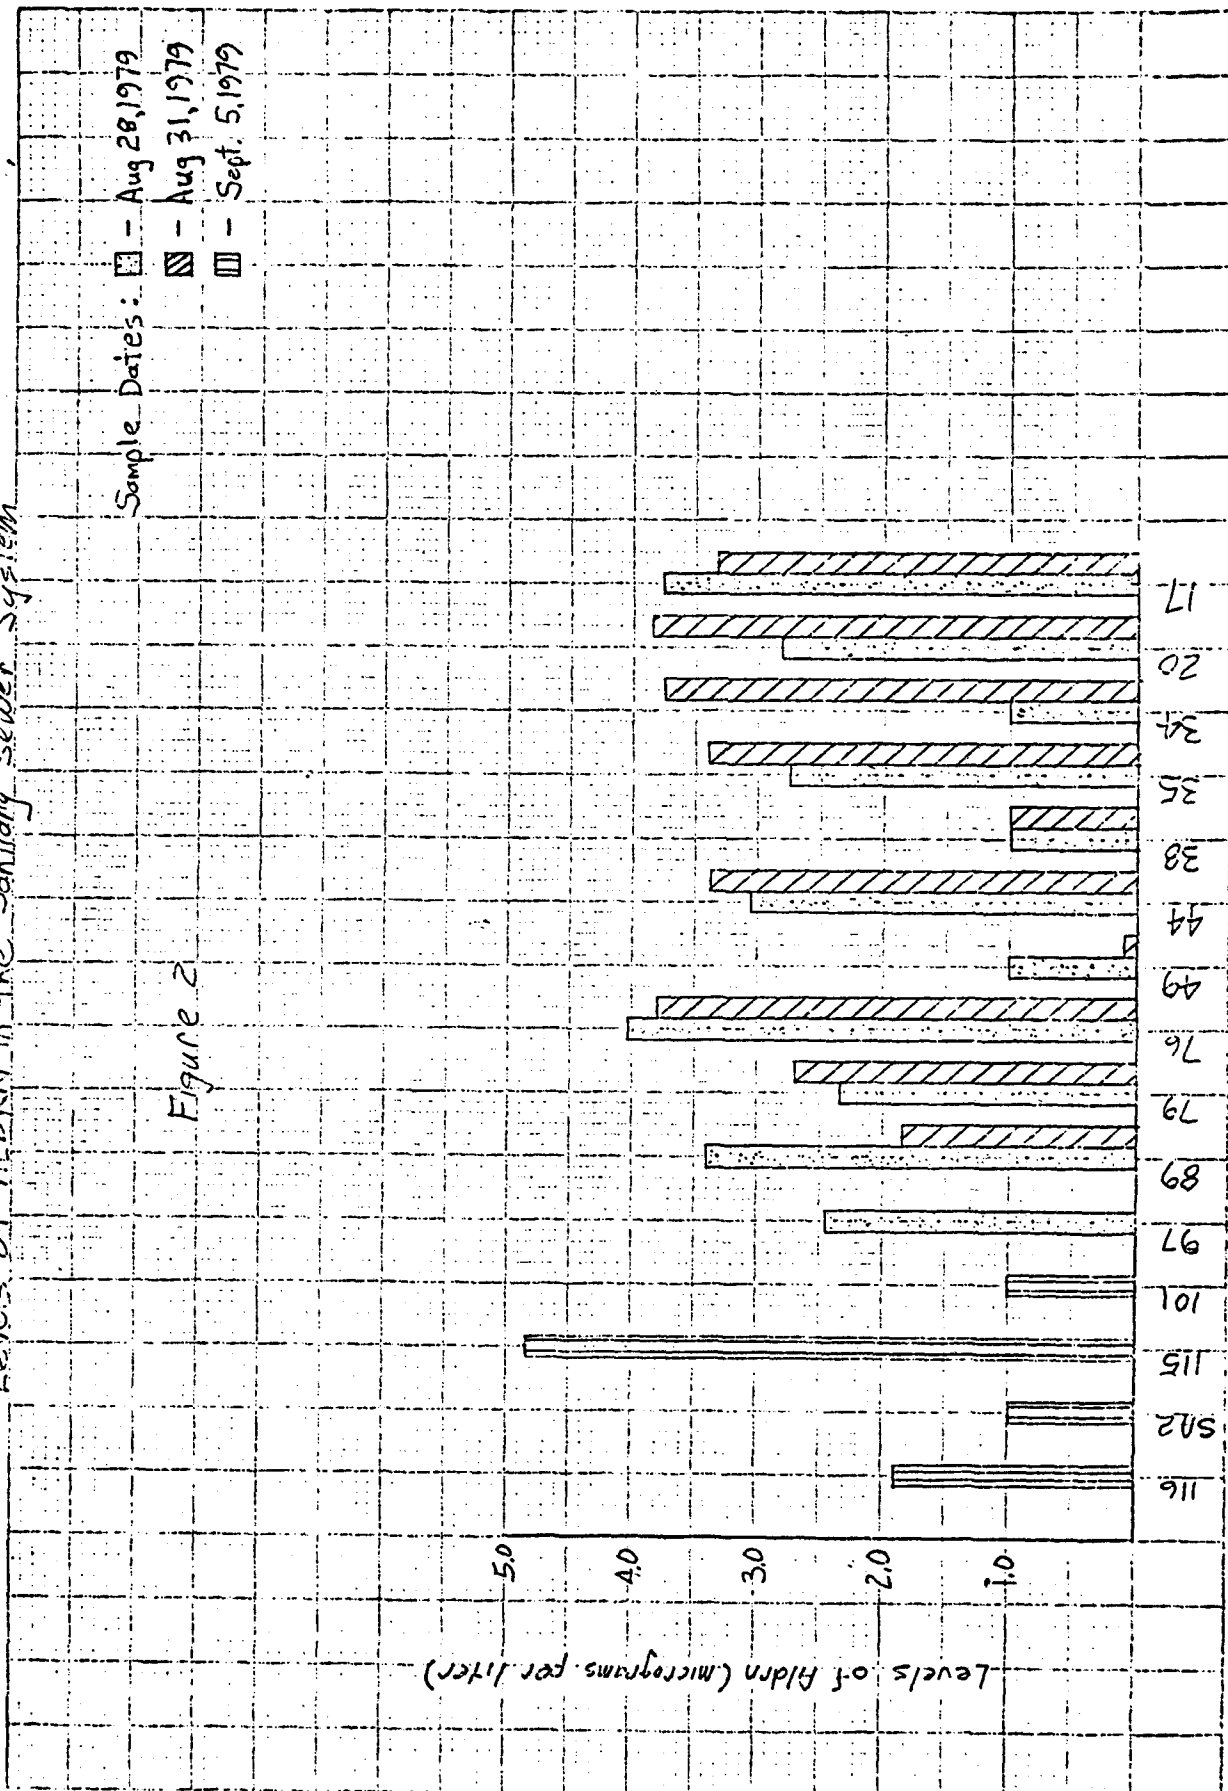
Levels of Aldrin in the Sanitary Sewer System

15. Sampled levels of DBCP, Aldrin, Dieldrin, and Endrin exceed recommended levels. These contaminants are a probable cause of the death of bacterial growth necessary for proper operation of the trickling filters.
